MODELLING FAILURE MECHANISMS OF SOFT CLIFF PROFILES

ABSTRACT

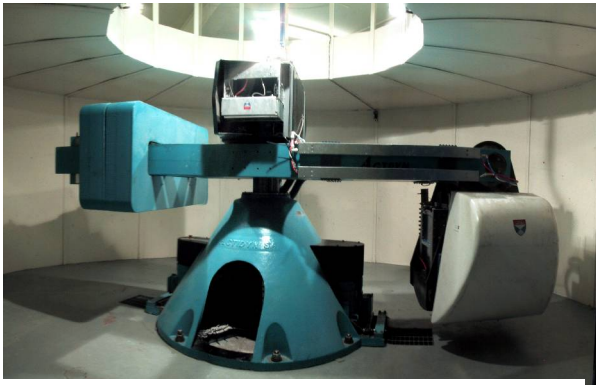
Figure 1. Dundee Geotechnical centrifuge

A number of scaled physical model tests were conducted using different cliff materials. These were simulated in the 7 m diameter (150 g-tons) Dundee centrifuge (shown in Figure 1).

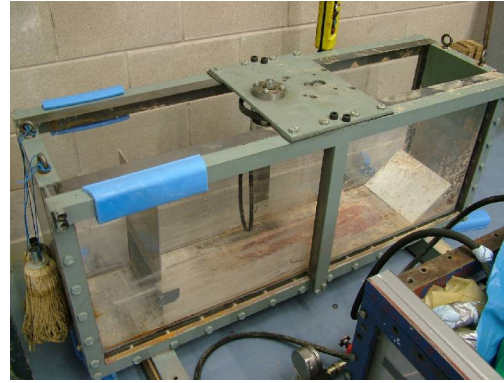
Figure 2. Wave flume container

Two dimensional plane strain soil models were tested in a specially design wave flume container of internal dimensions 1500 mm x 450 mm x 400 mm (shown in Figure 2), which formed the centrifuge strong box. The flume box has Perspex sides, so that the model may be viewed from the side during testing.

Digital video cameras (viewing the side and top of the model) were used to record soil movements (via the use of small side markers and a grid system) and provide information on the failure mechanisms.

Drainage was accomplished using a basal filter system and the internal water table in the cliff was controlled by adjusted the head of water at the base filter.

Wave loading was created using a quasi-flap paddle system that was located at the opposite end of the centrifuge box. Wave probes and pore pressure transducers were used to monitor the wave height and period. Internal pore pressures (and /or suctions) will also monitored within the slope using miniature pore pressure and tensiometer devices. In order to correctly scale the dynamic and diffusive events (Dong et al., 2001) it is required to use a more viscous fluid than water. Some of the later testing has employed metholose like Dewoolkar (1999), however the tests reported herein have used de-ionised water only.

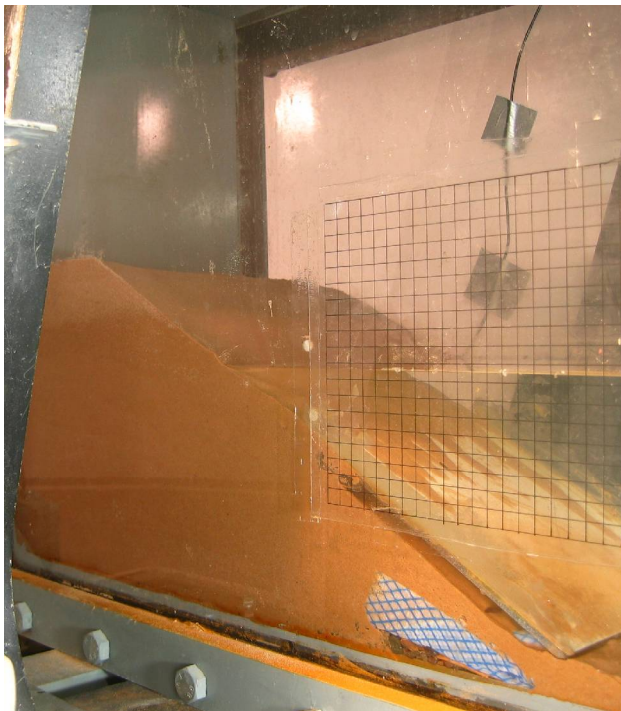
Figure 3. Example sand and cement cliff slope

Cliffs were created with model heights varying from 25-30 cm and slope angles of 30, 45, 60 and 80° (see Figure 3).

Model cliffs were made using a fine silica sand (known as Congleton sand). This material is uniformly graded with $d_{50} = 0.3$ mm, $G_s = 2.65$ and the particles were surrounded. The angle of repose of the loose soil was measured to be 32° and this is believed to be close to the critical state angle of friction.

The maximum and minimum densities of the sand are 1.78 and 1.39 g/cm^3 respectively. All of the models were mixed at 10% moisture content and placed in the flume box by hand prior to cutting to the required geometry and height.

Additional quick drying Portland cement was added to a number of the mixtures prior to placement at concentrations of 0.5, 1 and 2.5 % (weight for weight).

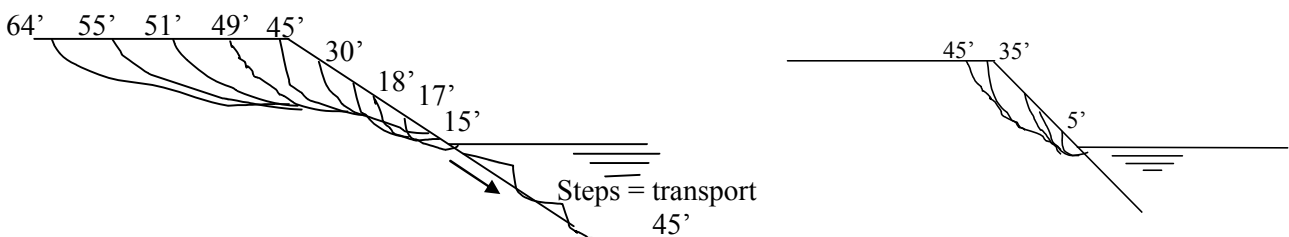
Figure 4.

Sand cliff erosion evolution profile for a 30° slope and for a 45° slope versus notching time

In order to get the most efficient erosion, some 2 cm crest waves are created to attack the beach and the toe of the cliff or the joint position, tending to form a stability equilibrium profile of the beach in the angle of repose of the sand material. From this new profile only 1cm crest waves are necessary to carry on an efficient notching. Figure 4 shows the evolution of the profile for the test 1 reported in table 1 for a cliff with a 30° slope and 45° slope. The process started with the cliff face becoming steeper gradually, then, eventually the cliff was so steep that it couldn't be stable any more. A tensile fault was produced on the top of the cliff and the collapse occurred inevitably.

When the wave run-up on the beach was sufficient the debris on the back shore from the previous collapse or the cliff toe (when it was not protected by debris) was eroded. Then the eroded material was removed from the cliff toe.

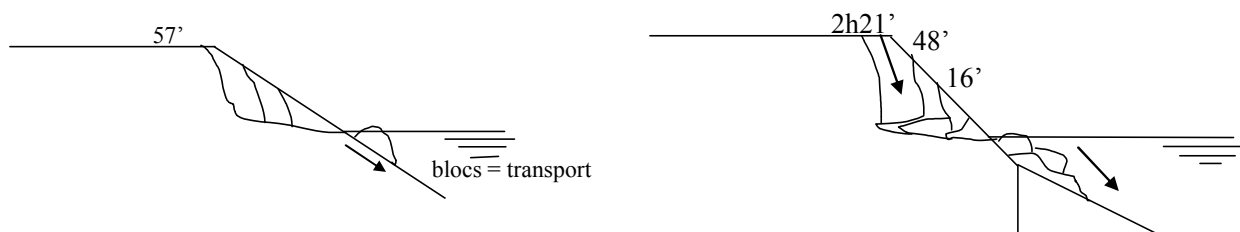
The wave action at the toe of the bluff gradually carved into the bluff material, creating a “notch”. The erosion caused again an undercutting on the face of the bluff. A clear indicator of cliff erosion is the presence of a notch, a laterally extending hollow at the base of a cliff, its width being greater than its depth. Then the notch is broadened and some tensile joints located on the bluff top appeared announcing an imminent block failure. When the notch reached a threshold depth, the weight of the overhanging bluff couldn't no longer be supported which ultimately lead to a catastrophic collapse of the bluff face with large sand and cement blocks falling down to the beach. The mechanism is showed on Figure 5 in the case reported in table 3 of a cemented cliff with a 30° and a 45° slope.

Figure 5. Cliff erosion evolution profile with sand and cement (1%) for a 30° slope and 45° slope

It has to be noted that the tensile fault on the top of the cliff is smaller on the pure sand cliff than the one made of sand and cement.

The notch or undercutting of the toe of pure sand cliff was smaller than the one of sand with cement. The failure mode of the collapse should be a straight fall, but the pure sand cliff was eroded very quickly after the fall. The sand cliff with cement collapsed gradually, generally forming some soil blocks deposited at the toe of the cliff.

As a comparative example with a real cliff, the scaled conversion gives a full collapse of 57 minutes for a 1 % cemented cliff with 45° slope in the geotechnical centrifuge corresponding to 35 days on the coast, the waves attacking the cliff having a 1.5 cm crest equivalent to 45cm. In the case of a sand cliff with the same slope angle the first collapse occurred only after 15 minutes corresponding to 9 days on the real scale with 30 cm crest waves.
